Development of self-healing carbon fibre reinforced plastic utilising an embedded hollow glass fibre delivery system

**Department of Aerospace Engineering
University of Bristol**

July 2008

**A dissertation submitted to the University of Bristol
In accordance with the requirements of the degree of
Doctor of Philosophy in the Faculty of Engineering**

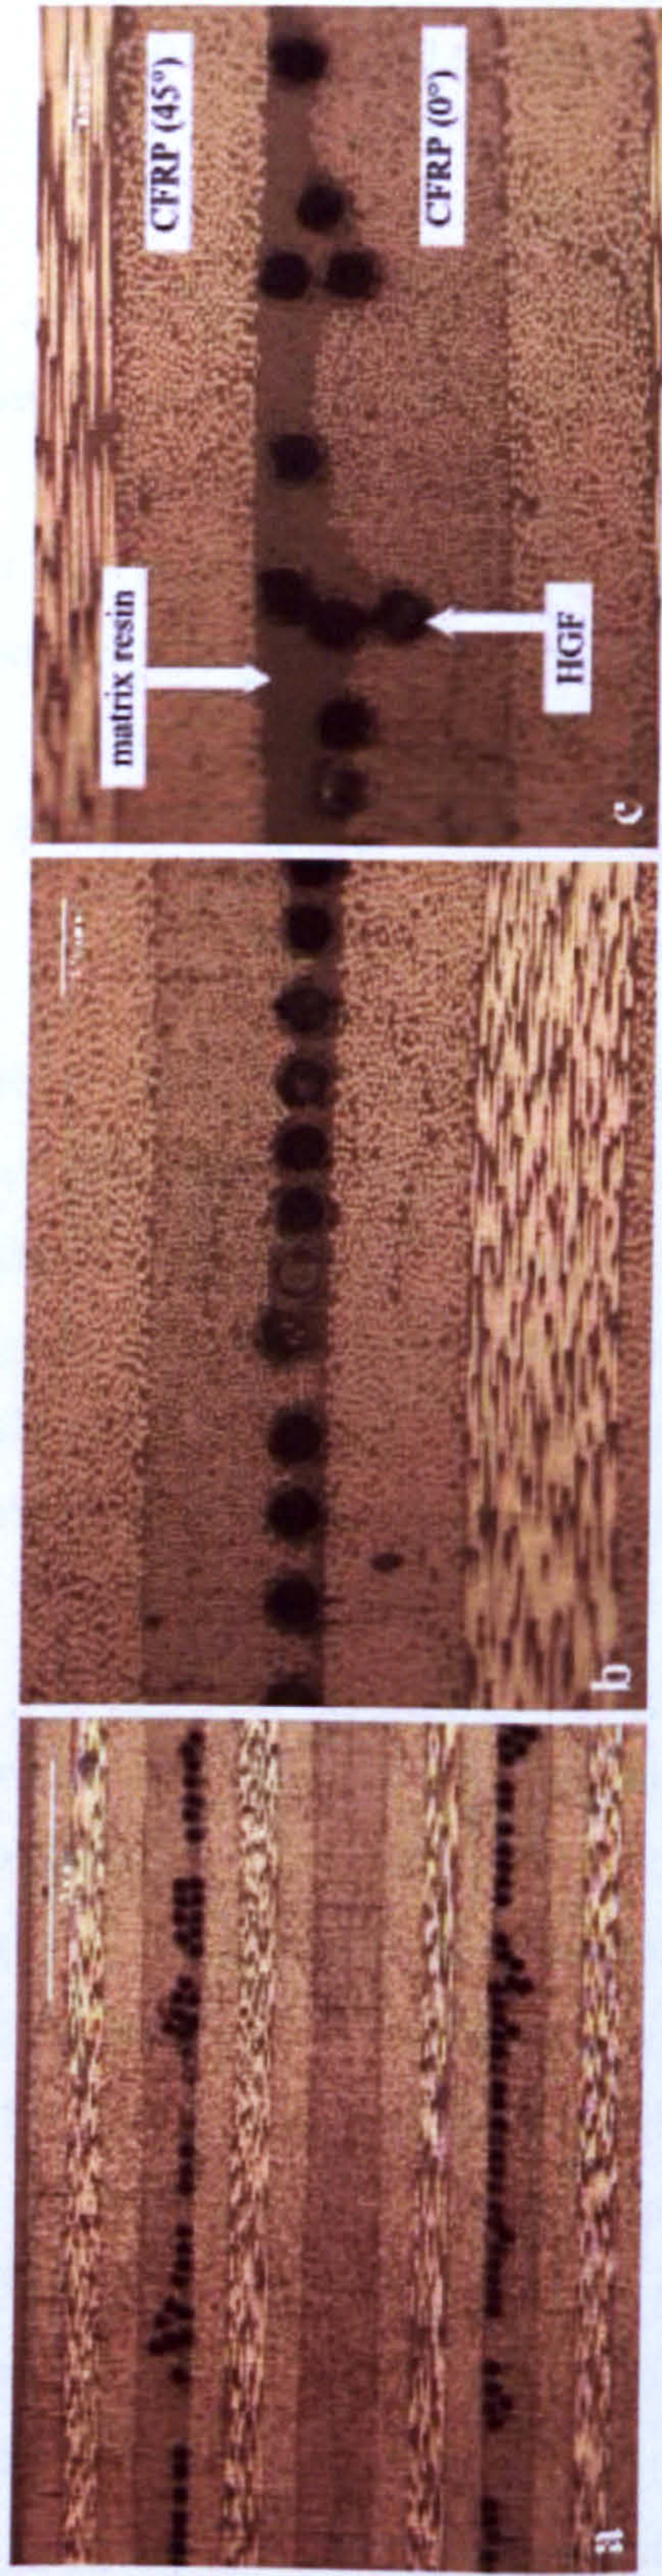
At 70 μ m spacing, the HGF are tightly packed (Figure 6-14b) as expected. However, some inconsistencies in HGF spacing have occurred during panel manufacture. These are attributed to variability in pitch rate control during the HGF manufacturing process, and also due to the low 'tackiness' of the 914 resin pre-preg allowing HGF to detach and re-attach at random. This often resulted in overlapping fibre which was not overcome during the laminate consolidation in the autoclave. The combination of these effects creates instances of HGF 'clumping' which results in resin rich regions Figure 6-14c.

Figure 6-14: a) Embedded HGF Spaced at 70µm showing b) Ideally Nested Side by Side and c) Fibre Clumping and Resin Rich Regions

The microstructure of the as-manufactured laminates can be seen in Figure 6-14 and Figure 6-15, which show the distribution of HGF embedded at 70 μ m and 210 μ m respectively.

It was expected that the creation of resin rich regions and HGF clumping would have the most significant detrimental effect on mechanical performance of the undamaged laminates. In addition, HGF clumping caused limited distortion (Figure 6-14c) in ply thickness as the carbon fibres were not able to reorganise sufficiently. This could potentially contribute to degradation in mechanical properties by causing waviness in the primary reinforcing fibres. It was considered that HGF clumping may actually increase the impact energy absorption capability by increasing the exposure of HGF to crushing forces and increasing the transmission of such loads between HGF at local clusters of fibre. As a consequence this would improve the overall damage tolerance of the HGF laminates for a given impact energy when compared to a baseline plain CFRP.

Analysis of the flexural test data (Table 6-5, Figure 6-18) shows that the HGF spaced at 70 μ m resulted in the largest reduction in undamaged strength (8%). This can be attributed to the significant disruption to the fibre architecture observed in Figure 6-14. However, after a quasi-static impact at 2000N peak load, this configuration exhibited a significant amount of additional damage tolerance when compared to the 210 μ m HGF spacing and plain baseline laminates. For the 2000N indentation the 70 μ m configuration achieved a 7% higher flexural strength compared to the baseline plain laminate. This apparent increase in damage tolerance can be attributed to energy absorbed by the crushing of HGF and is supported by the more widely spaced 210 μ m results which demonstrated values similar to that of the plain baseline laminate. It appears that the initial reduction in strength due to the presence of a significant volume of HGF is offset by an increased damage tolerance. The large volume fraction of HGF in this configuration also provided a larger volume of healing agent as demonstrated by the healed samples achieving 97% of the undamaged strength which

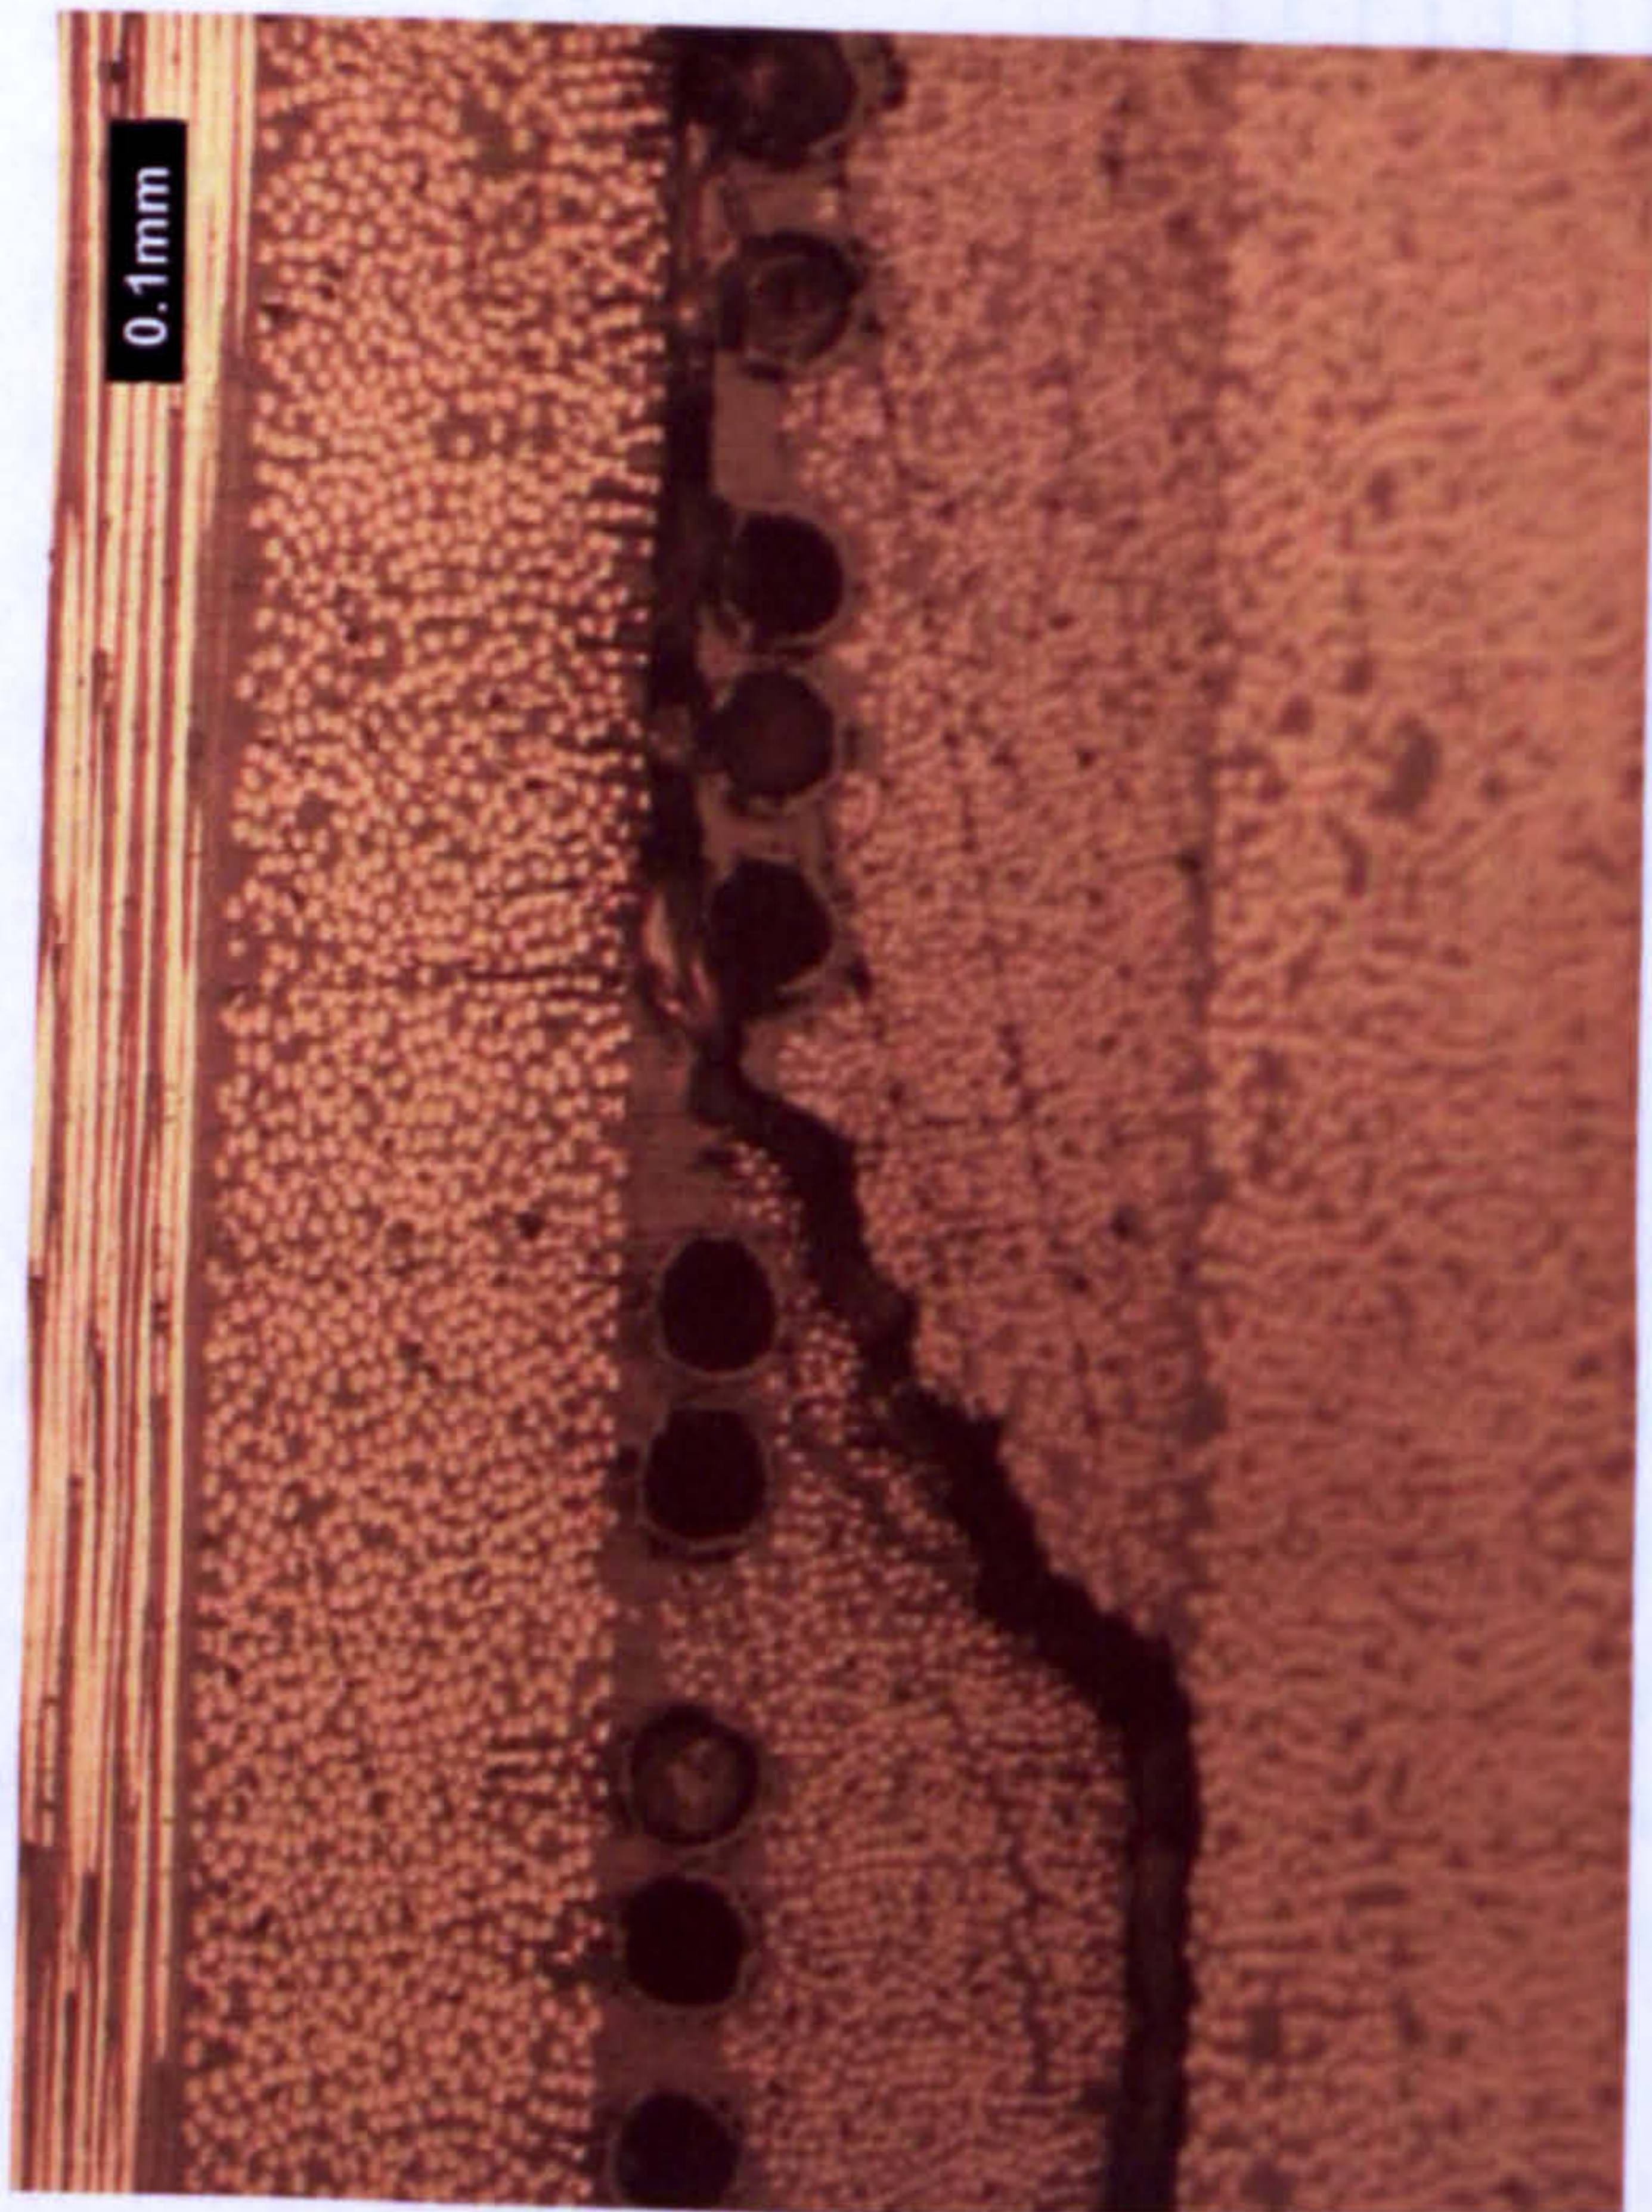
Figure 6-21: Optical Micrographs of Shear Cracks and Delaminations Fracturing HGF

The HGF immediately beneath the impactor was subject to ‘crushing’ forces, the consequences of which were difficult to discern clearly using optical microscopy. However, the majority of HGF fracture within the laminate is evident from Figure 6-21 where shear cracks and delaminations intercept regions of HGF. Furthermore, Figure 6-20b shows similar damage infiltrated with healing resin mixed with Ardrex 983 UV fluorescent dye. It can be seen from this image that the larger delaminations contain only a limited volume of healing resin. This could be due to the following issues:

Intra-ply shear cracks are seen to link multiple delaminations in Figure 6-20, Figure 6-21 and Figure 6-23. The presence of these shear cracks is essential for effective self-healing as they provide connectivity between different damage sites in the laminate and facilitate healing at multiple interfaces. Shear cracks can also be seen to have initiated HGF fracture in preference to reinforcing fibre fracture (Figure 6-21). However, the thickness of shear cracks (10µm) is generally smaller than delaminations (30µm) and so they would be expected to generate a larger capillary action (inversely proportional to the radius of the opening between two surfaces).

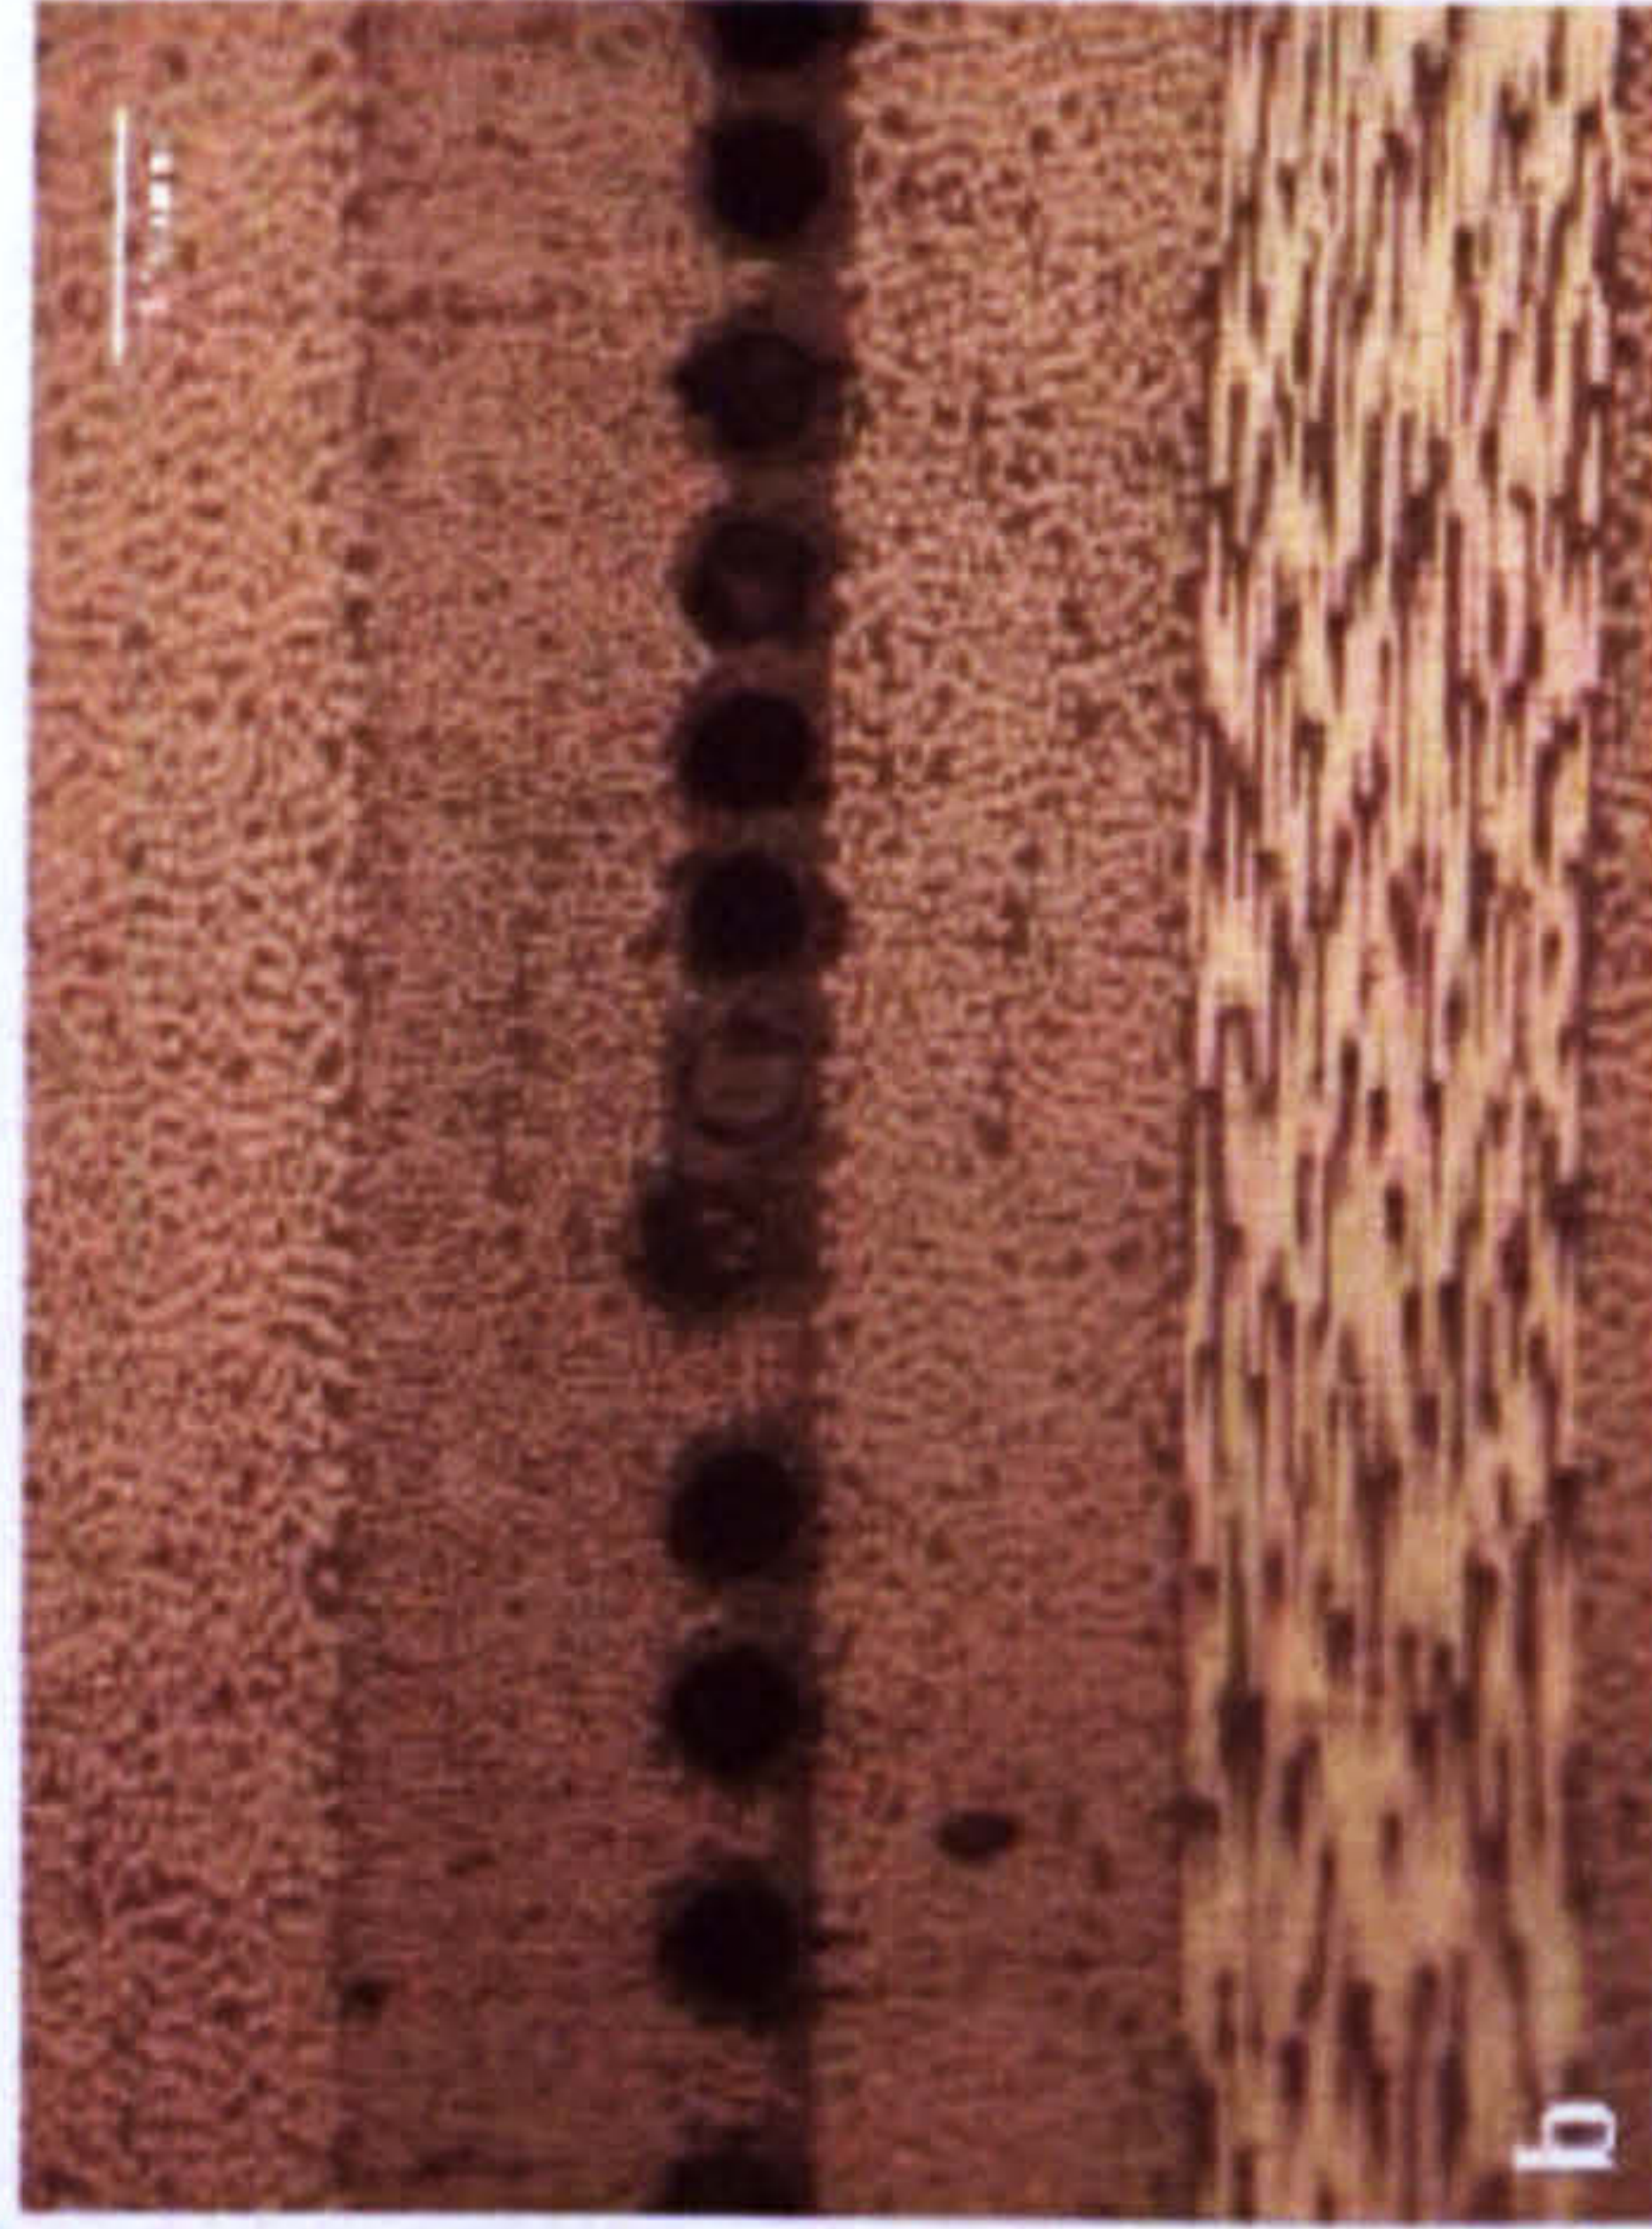
Figure 7-15: a) Embedded HGF Spaced at 70µm showing b) Ideally Nested Side by Side and c) Fibre Clumping and Resin Rich Regions

The 70µm, 140µm 210µm HGF spacing configurations can be seen in Figure 7-15, Figure 7-16 and Figure 7-17 respectively. It can be seen that the efficiency of HGF embedment improved as the HGF packing density decreased. This was attributed to the reinforcing carbon fibre having sufficient space to migrate between the large HGF during the consolidation process when the matrix resin is reduced to a sufficiently low viscosity. If the HGF spacing was small, the reinforcing fibres were constrained which resulted in the generation of resin rich regions identified in Figure 7-15c.

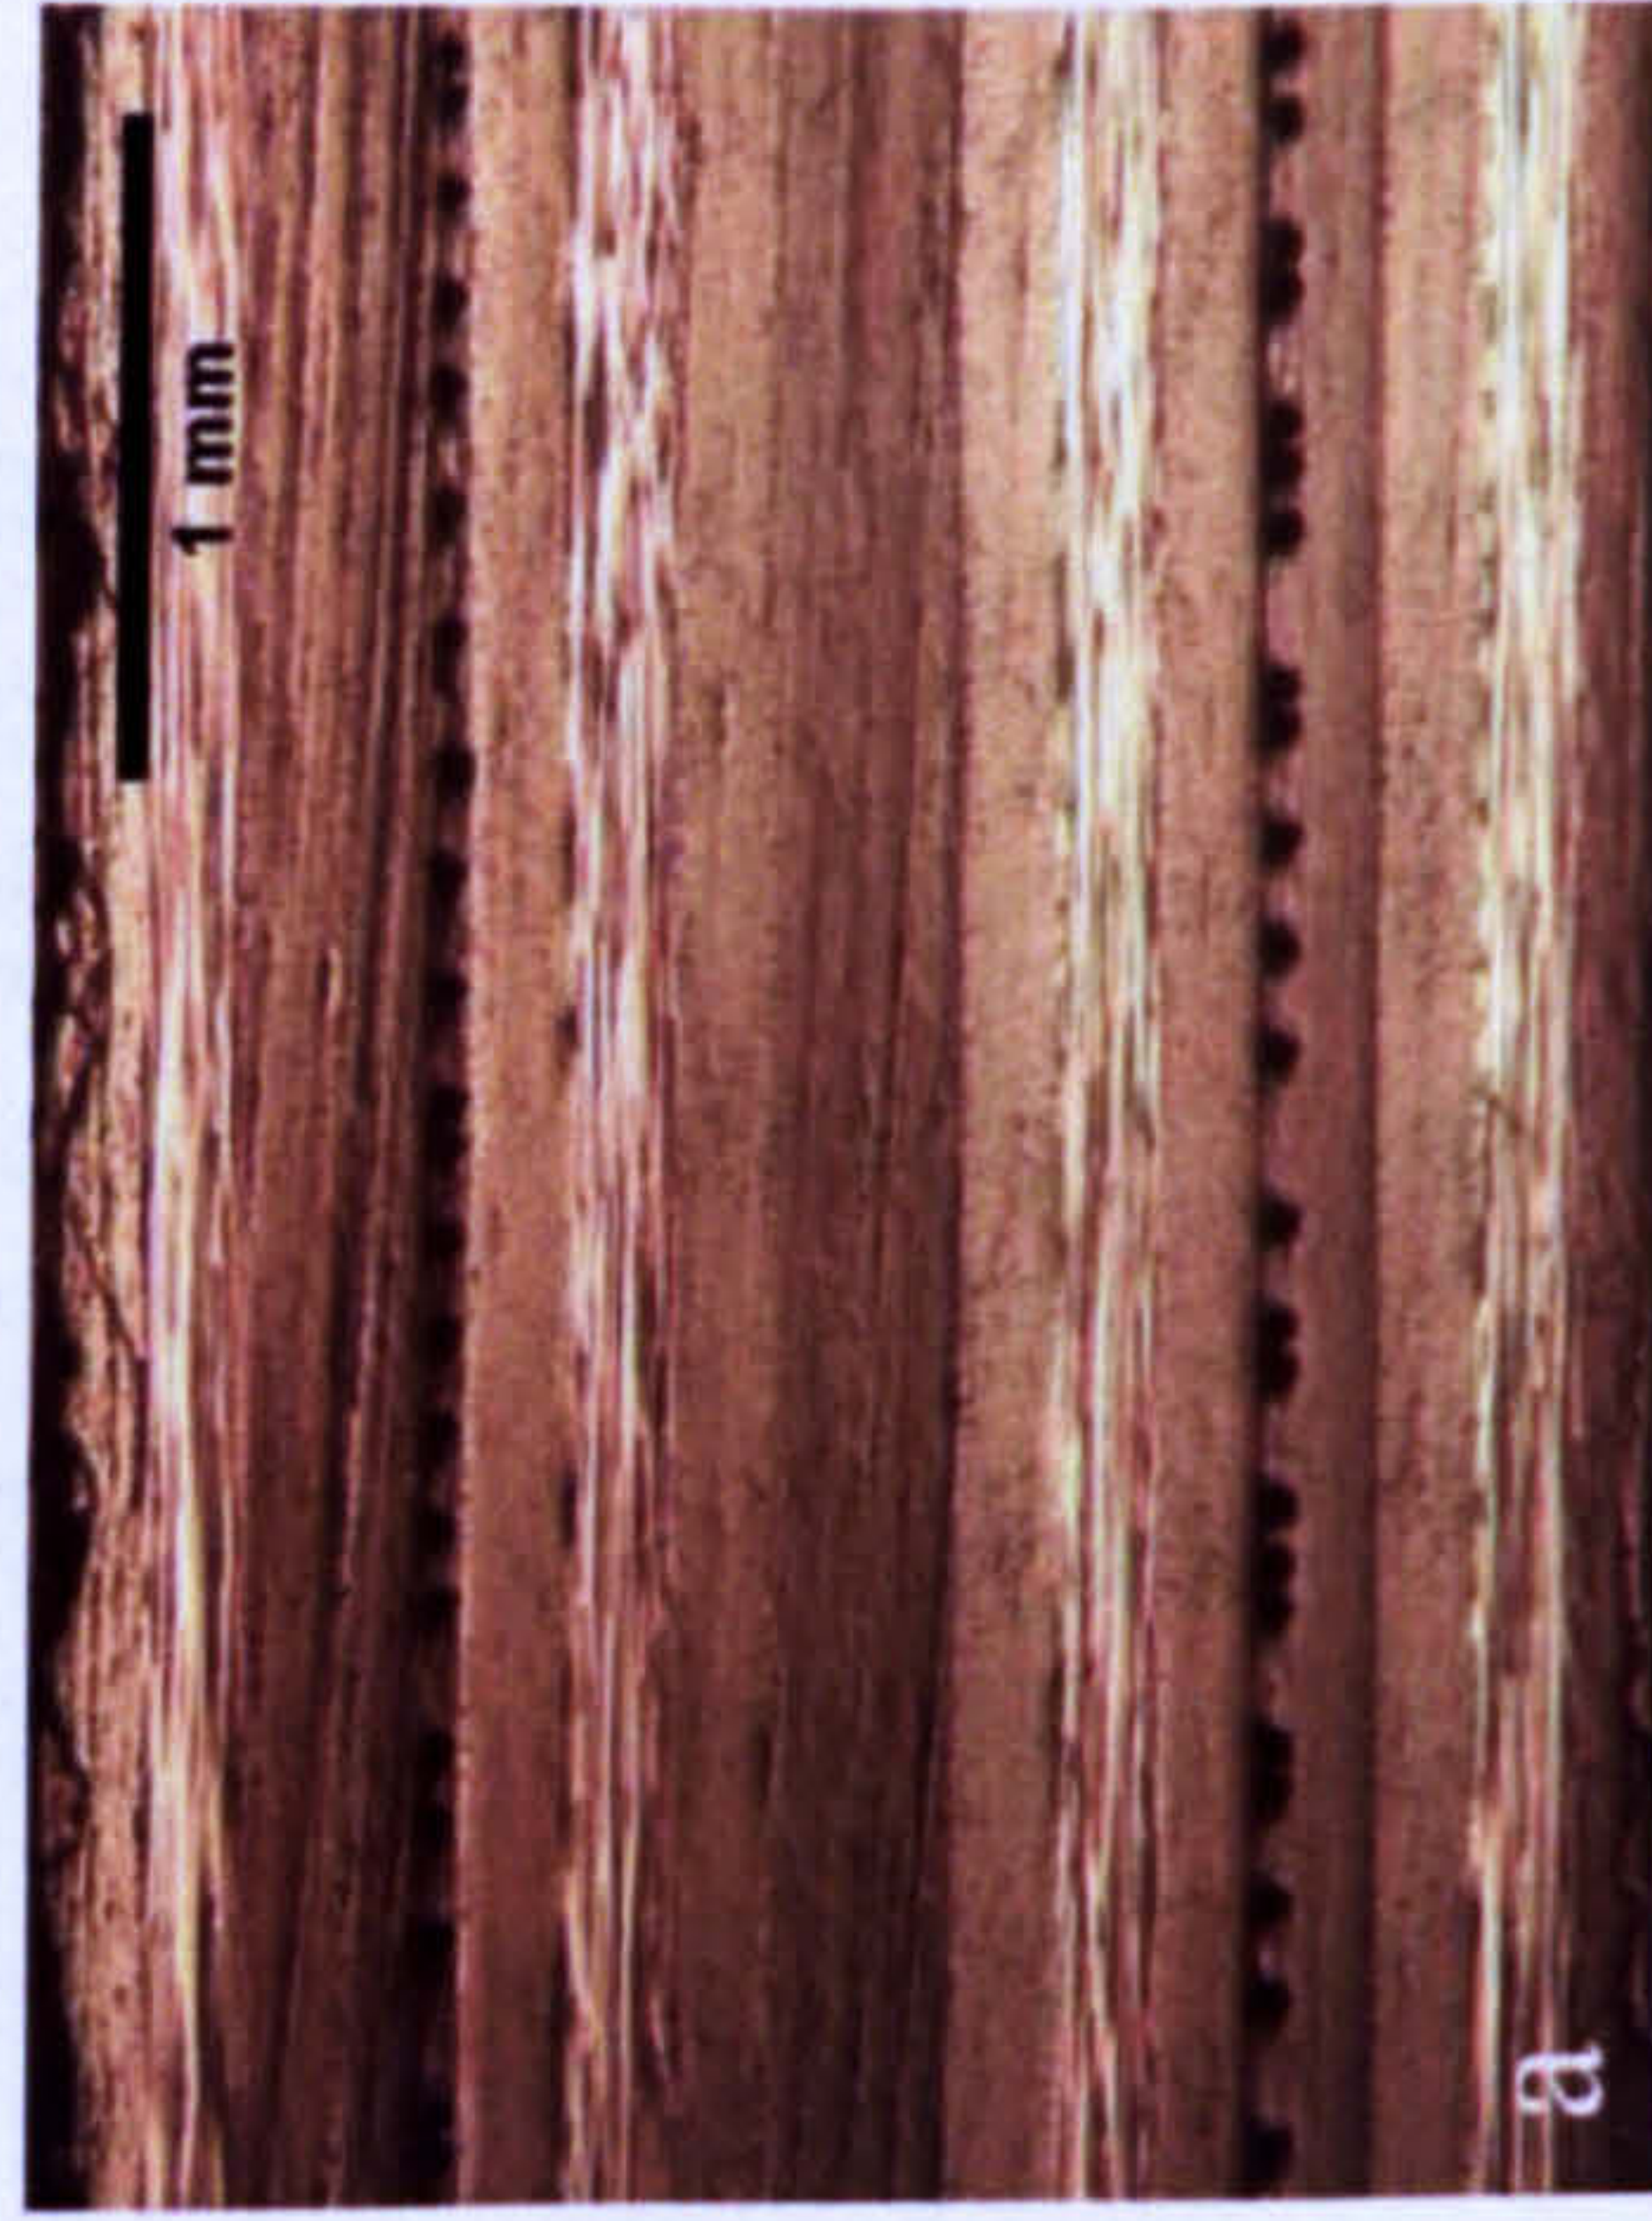
Figure 7-16: a) Embedded HGF Spaced at 140µm Showing b) Ideally Spaced at Two HGF Diameters and c) Excellent Embedment

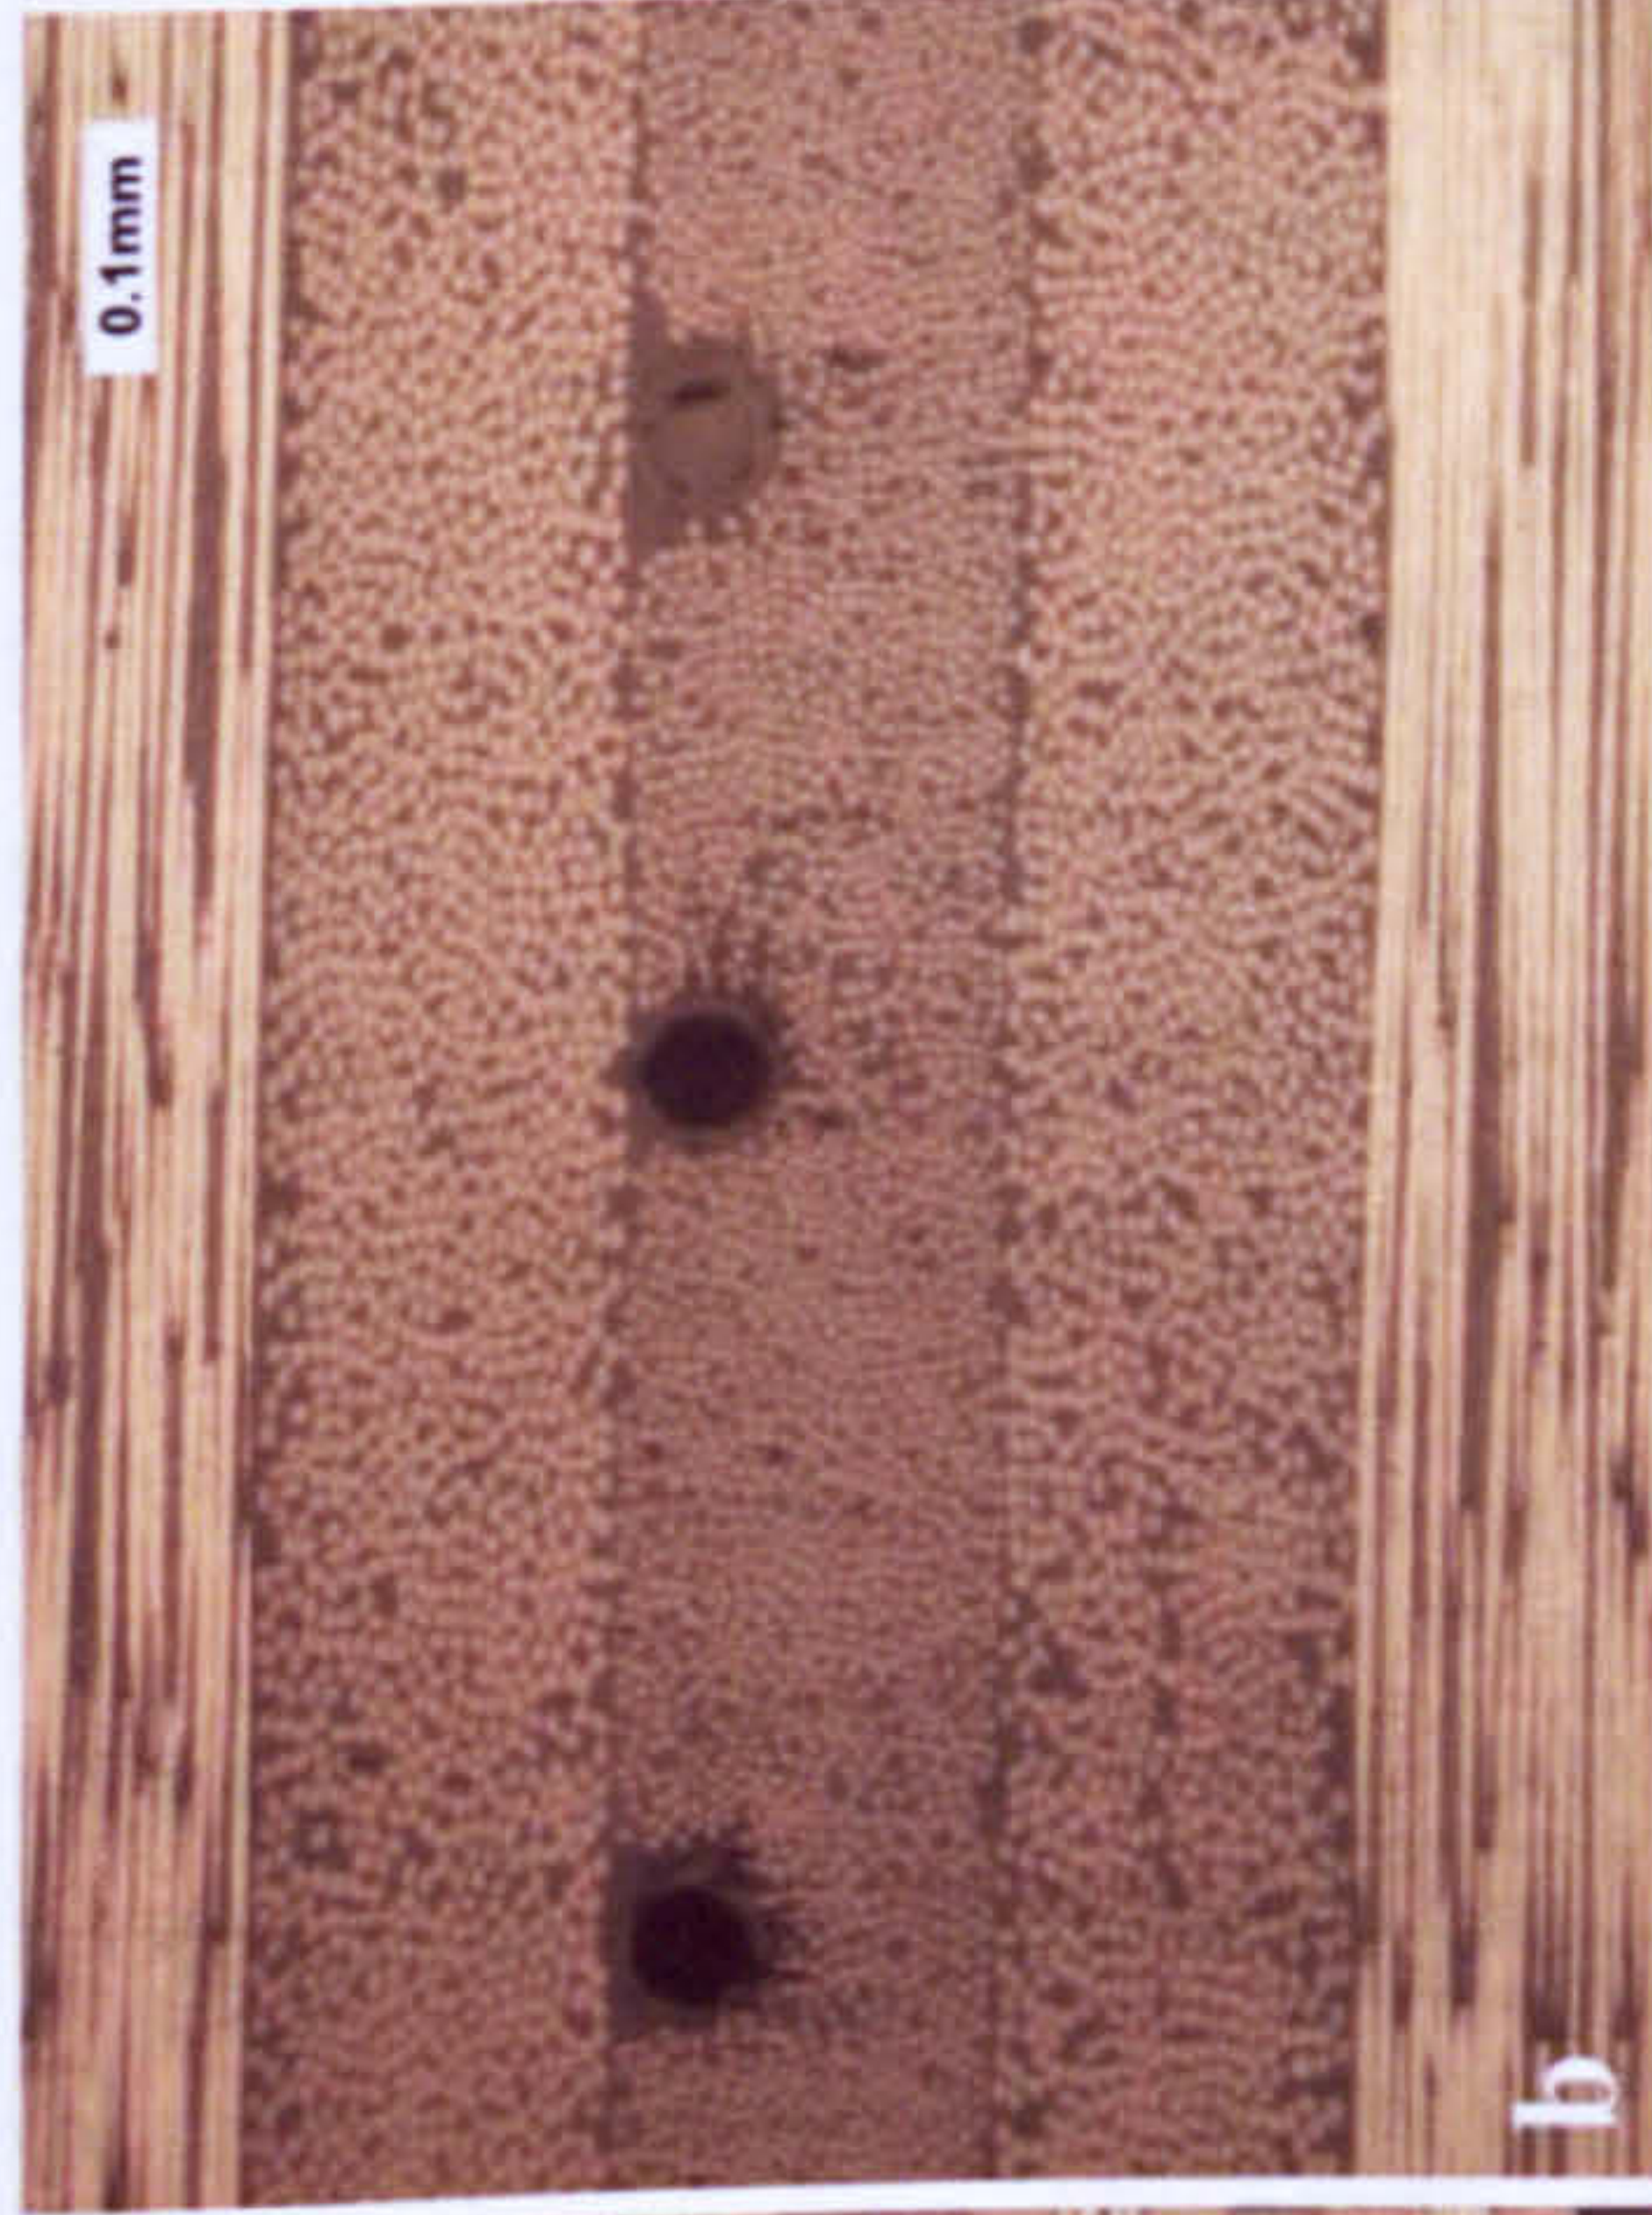
Figure 7-17: a) Embedded HGF Spaced at 210µm showing b) Ideally Spaced at 210µm showing b) Perfect Embedment

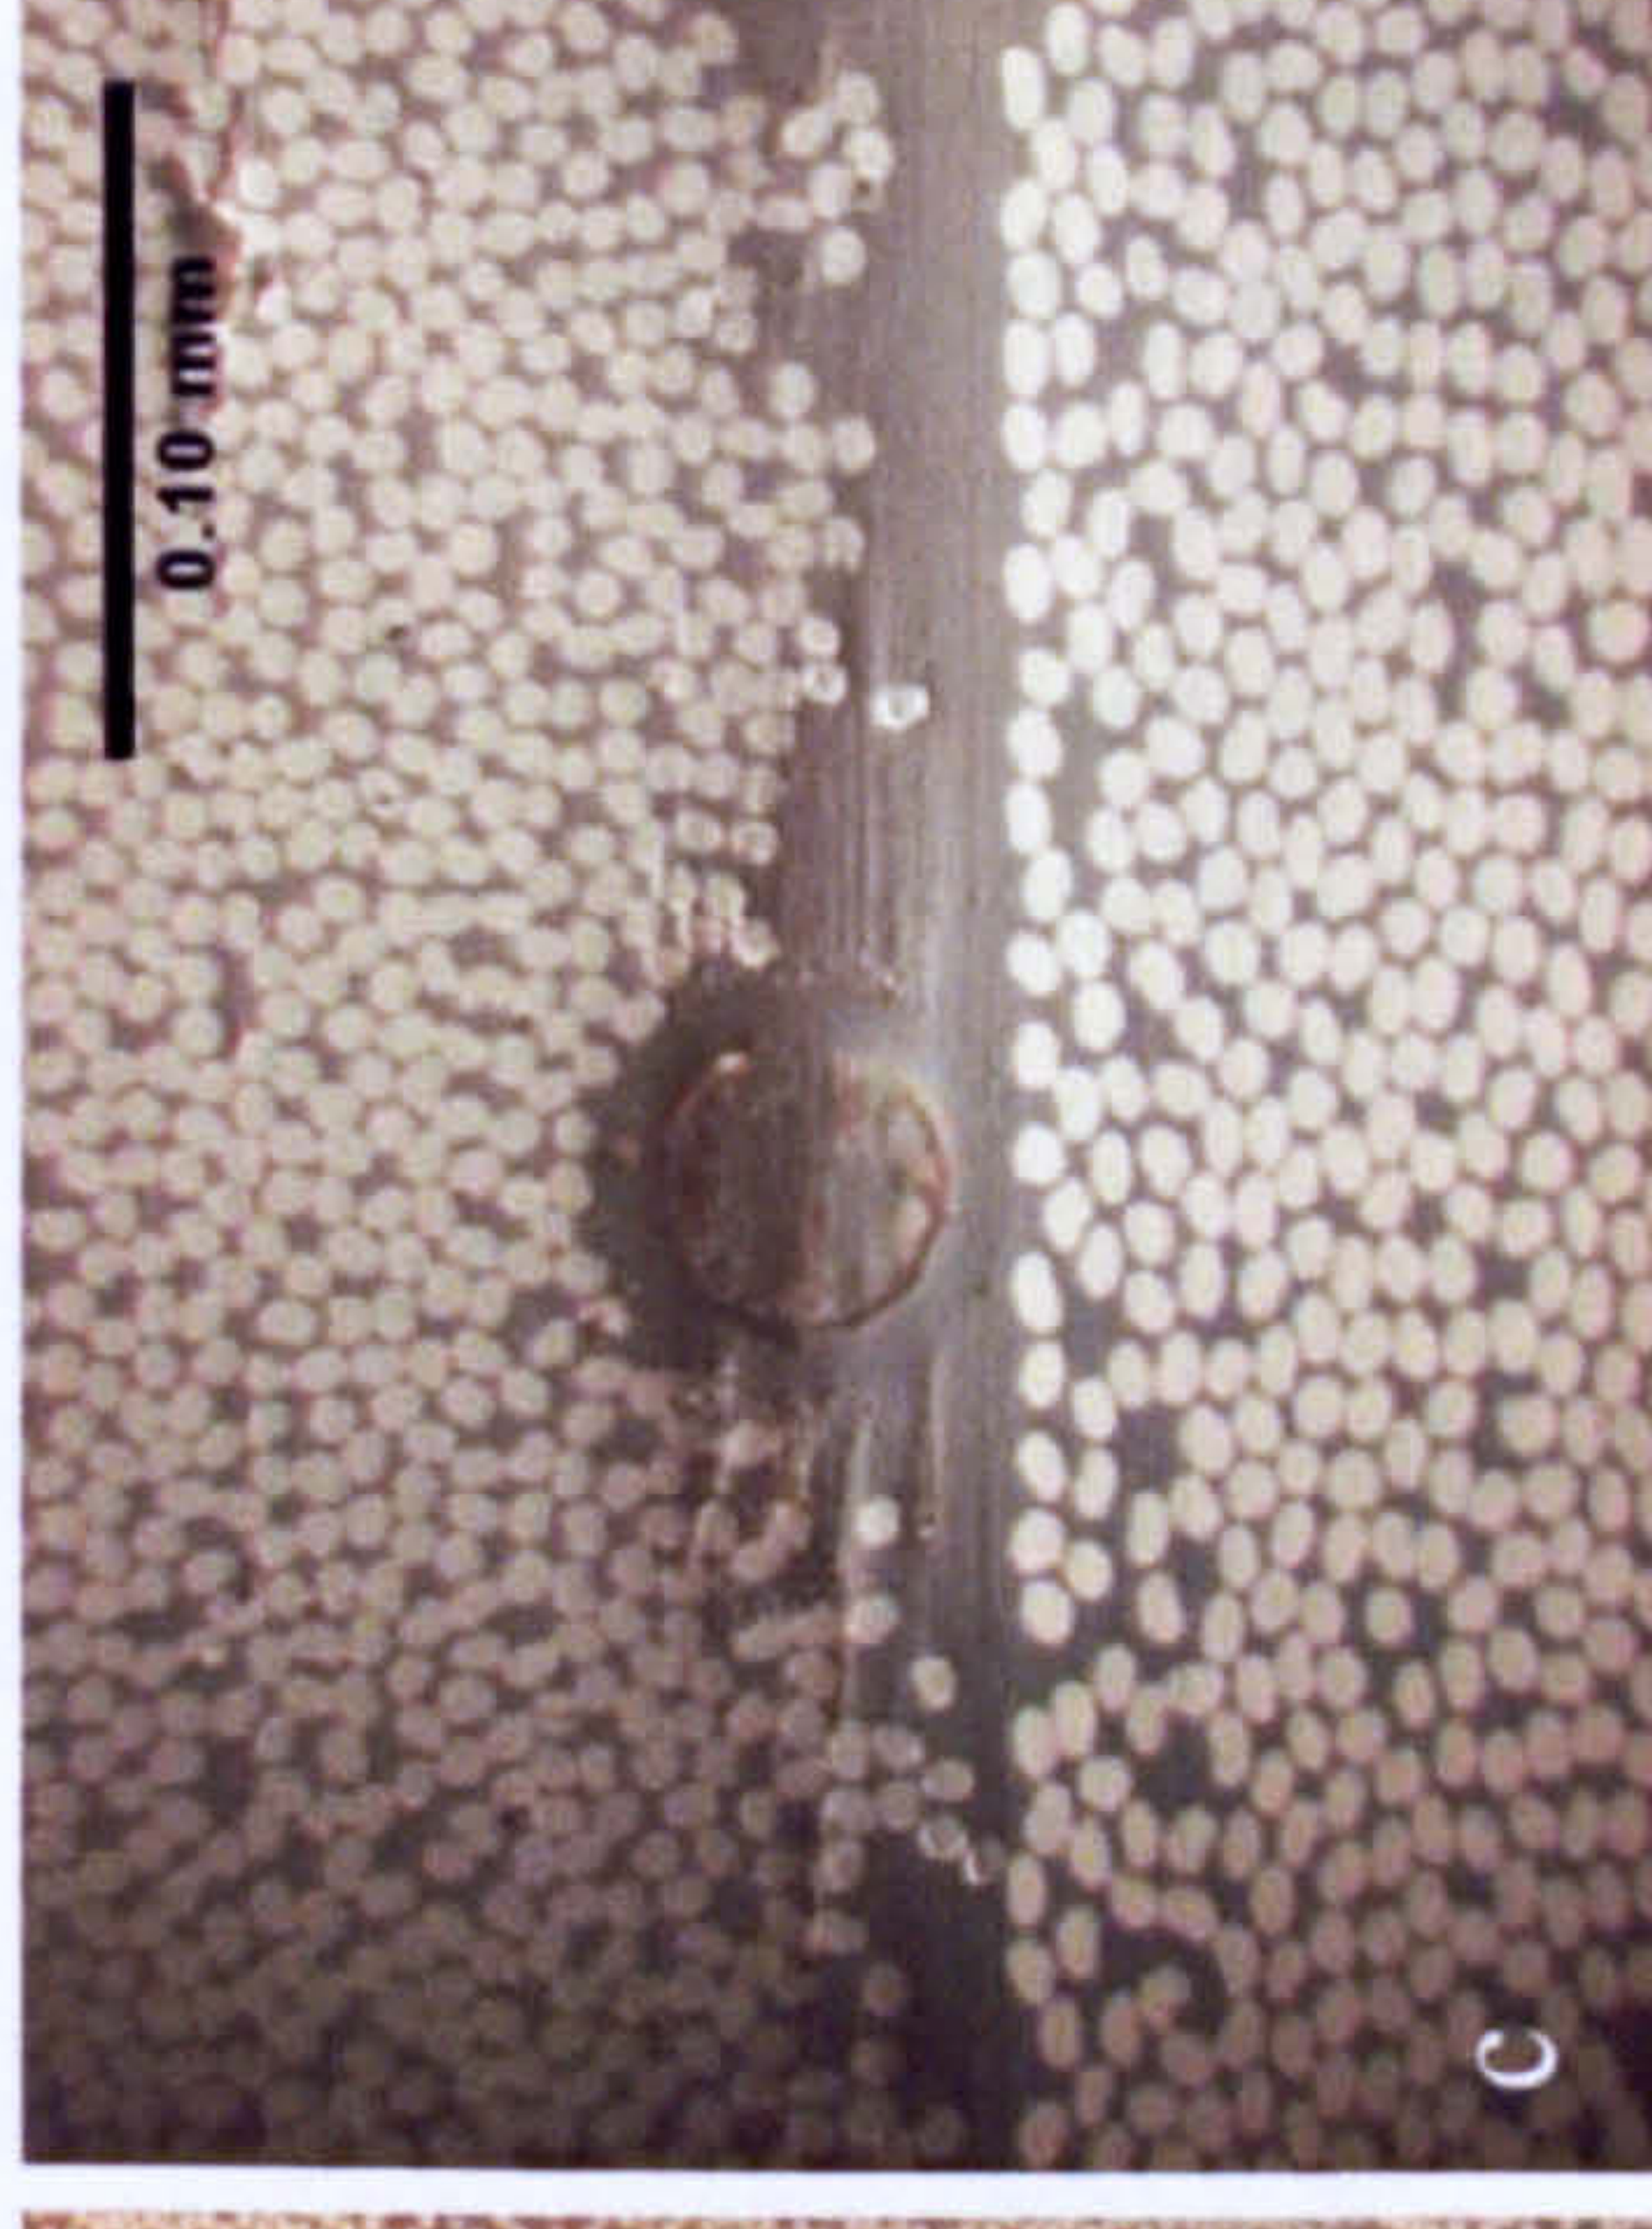
Figure 7-18: a) Embedded HGF Placed at Four Interfaces, Spaced at 210µm showing b) Differences in Embedment within Laminate and c) Poor Embedment at One Interface

It can be seen in Figure 7-18 that the HGF spaced at $210\mu\text{m}$ on four interfaces embeds very efficiently at all but one interface (Figure 7-18b and c). This interface corresponds to sub-laminate 2 (“TOP1” Figure 7-10) and highlights the problems encountered when HGF is overlaid onto a non 0° CFRP ply. In this case the HGF was overlaid onto a -45° ply direction and as a result, the quality of HGF embedment was significantly reduced. This was attributed to two factors:
